## Carson City Elevated SAFECOM

1. **SUMMARY.** At approximately 1030 hours on August 17, 2011 a vendor-operated Type 1 helitanker (S-64E helicopter) supporting BLM fire suppression operations the Ray May Fire released a load of water in close proximity to three firefighters from a ground firefighting crew. All three firefighters fell into rock scree (loose rock debris) with two of the firefighters receiving minor injuries that required transportation to medical facilities.

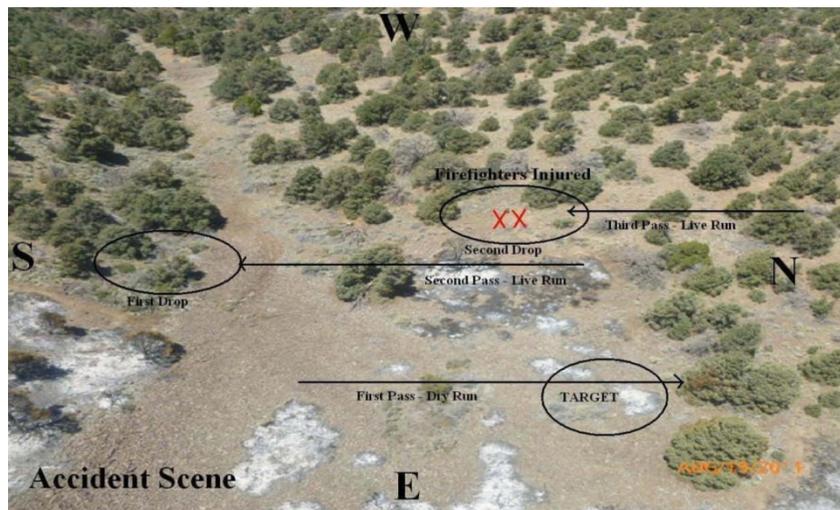
5. The crew captain provided feedback on the drop and instructed the pilot to move one rotor width to the Northeast of his last drop and drop sooner. At approximately 1031 the helitanker circled around and conducted the second drop which impacted three firefighters (figure 1).

Figure 1. Overview provided by BLM investigation.
