Caliente Elevated SAFECOM

1. **SUMMARY.** On August 26, 2011 a lead helitack crewmember was in the process of loading two firefighters and their equipment into a vendor-operated AS 350 B2 helicopter when he attempted to “toss” a chainsaw file out from under the operating rotor system. The file struck one main rotor blade damaging it to the point that the rotor blade had to be replaced. There were no injuries and the mishap was immediately reported using proper protocols.

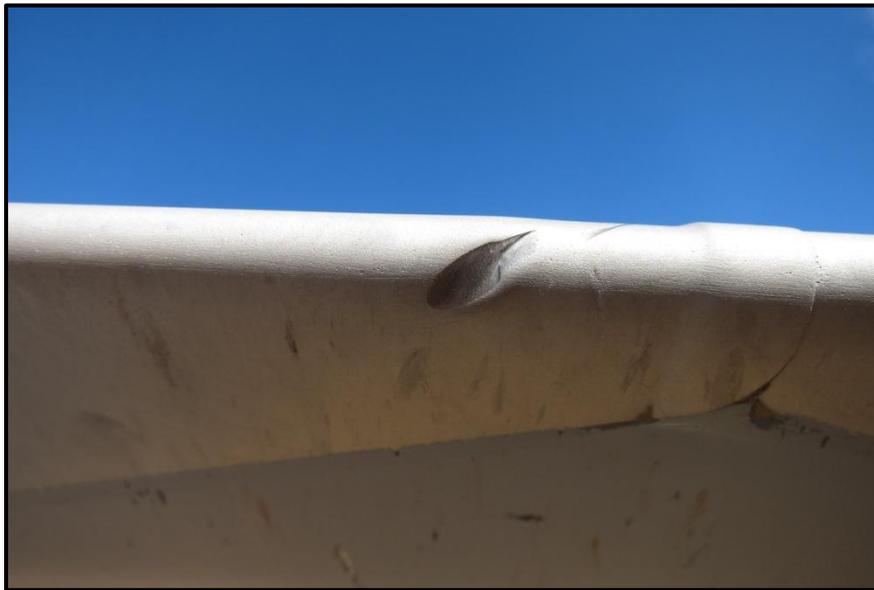
6. The file struck and damaged one main rotor blade but fortunately did not strike any of the personnel around the helicopter. The lead helitack crewmember was unaware that the file had struck the rotor blade until an observer outside of the rotor system told him of the incident.

7. The lead helitack crewmember immediately notified the pilot who shut down the aircraft and called for a company mechanic to inspect the damaged rotor blade. The mechanic determined that the damage would require replacement of the blade (figure 3).

Figure 3. Close up view of damage to main rotor blade.
