Bureau of Land Management

Elevated SAFECOM 13-0506, Single Engine Air Tanker N896WP, Wells, NV.

July 16, 2013

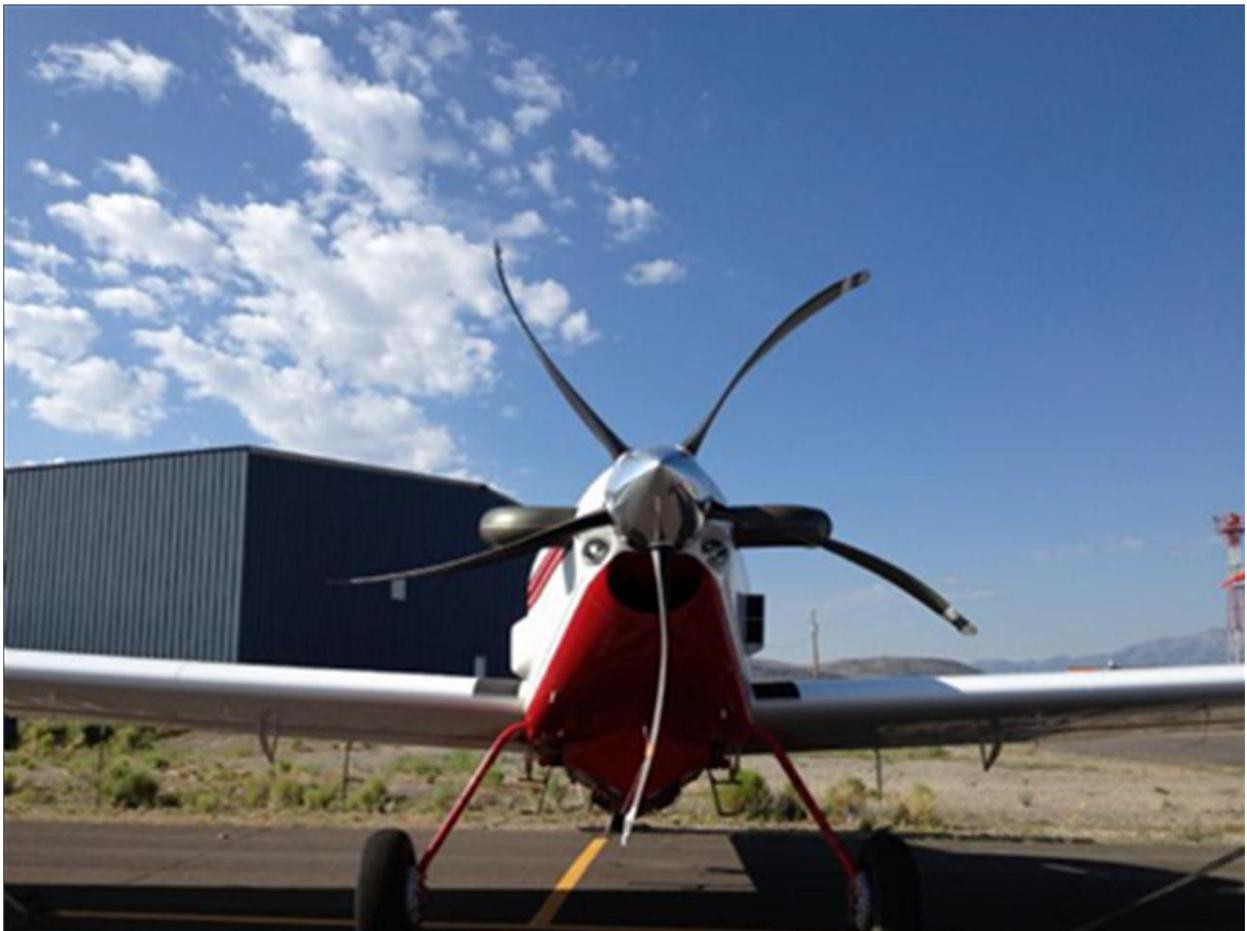
The mishap pilot stated that while he was writing down the time from the SEMG, he became distracted and did not notice the aircraft drift into the fuel pump. He further stated that the poor ambient lighting didn't allow him to perceive movement of the aircraft. Although the propeller was feathered, the turbo propeller engine still emits some residual thrust. When the propellers impacted the fuel pump equipment, the mishap pilot shut down the engine.

Damage to the aircraft propeller.

1. Contractor completes a comprehensive review of mishap pilot's assigned collateral duties and any extracurricular personal activities to determine the impact on his ability to adequately compartmentalize competing priorities and safely operate in the aerial firefighting environment.
2. Mishap pilot provide training to other vendor operators on the lessons learned from this mishap.
3. Mishap pilot review company SOP on ramp and refueling procedures and revise as needed.
4. Mishap pilot develop recommendations and best practices for the Wells, NV municipal airport ramp /fueling area and forward them to the BLM Nevada State Aviation Manager (SAM) via the OAS Aviation Safety and Program Evaluations Department.
5. Mishap pilot successfully complete a check ride prior to being issued a DOI Airplane Pilot Qualification card.

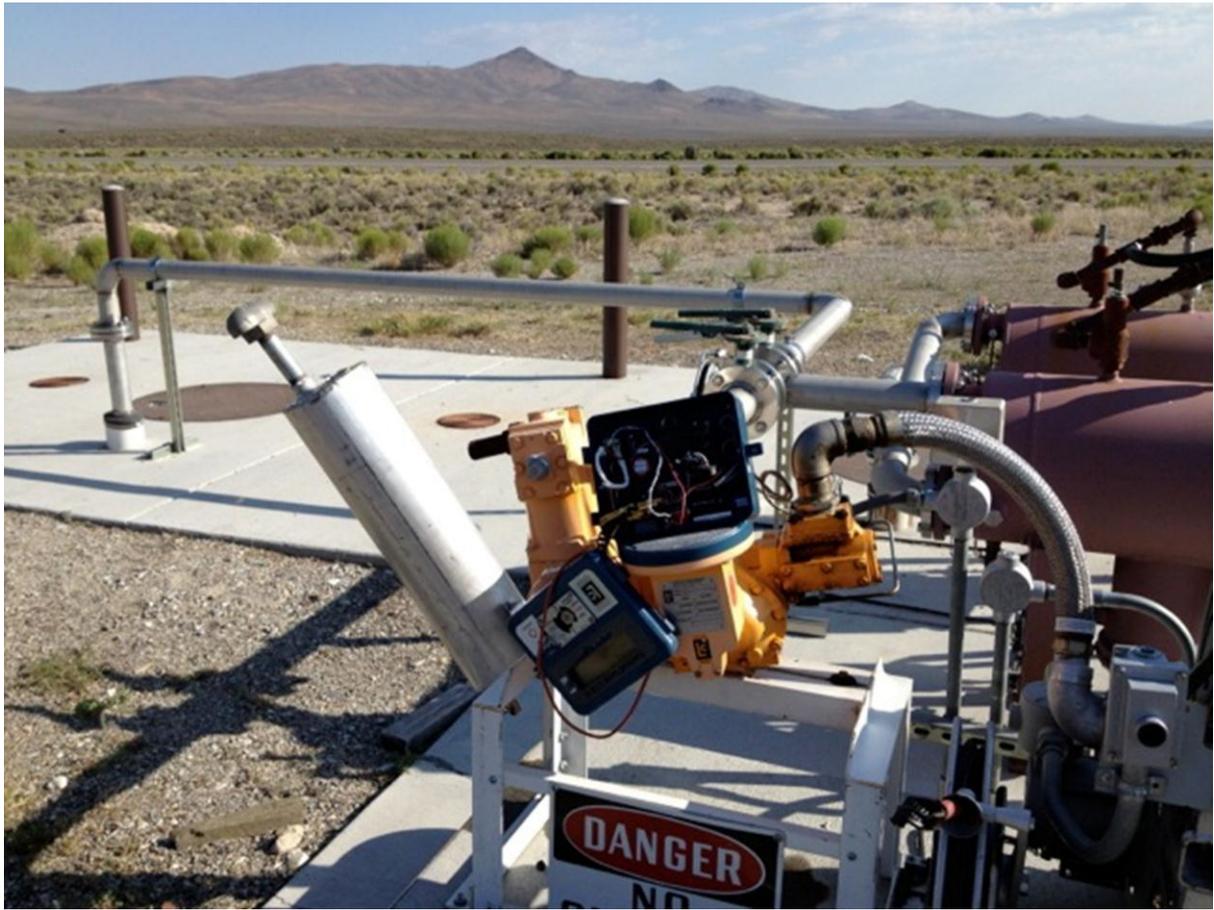
After the mishap, the pilot and SEMG inspected the fuel pump for any leak that might have resulted for the impact. They did not observe any leakage but did shut off all electrical power to the fuel pump as a precaution.

Damage to the fuel pump equipment.
