Southwestern Region Aviation Lessons Learned High Impact Tail Rotor Strike Incident With Potentail May 21st, 2014

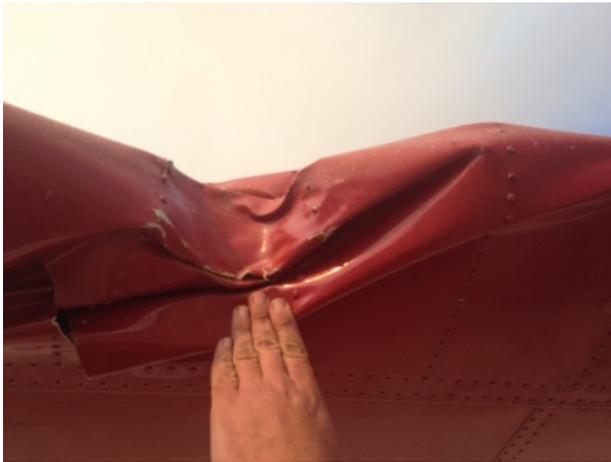
All four tail rotor blade tip caps were damaged as a result of contact with the tree. One tail rotor blade had damage that required replacement as it was not field repairable. The horizontal stabilizer was damaged from contact with the tree and also required replacement. The tail rotor drive hub, tail rotor gear box and all tail rotor drive shafts and hanger bearing assemblies were inspected with no defects noted. Post inspection review of the maintenance manual confirmed that the aircraft experienced a “high impact tail rotor strike” and not sudden stoppage.

Image identifying damage to Horizontal Stabilizer which required replacing.

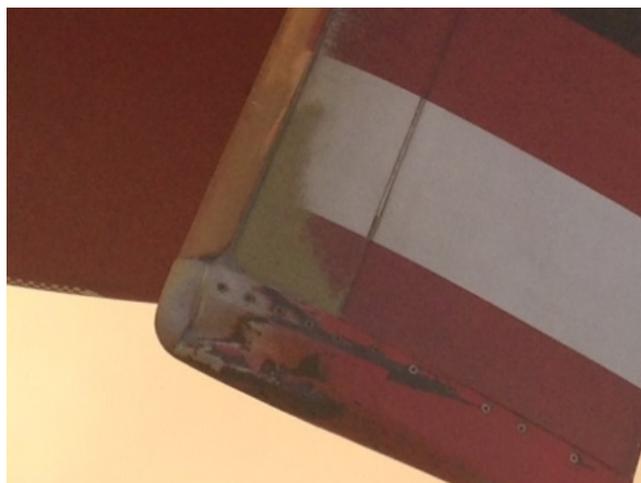
Image identifying damage to tail rotor blade tip. One tail rotor blade had damage that required replacement as it was not field repairable.
