**Bureau of Land Management
Aircraft Incident-With-Potential**

Bureau of Land Management, Incident-With-Potential, N5000G
Burns, OR.

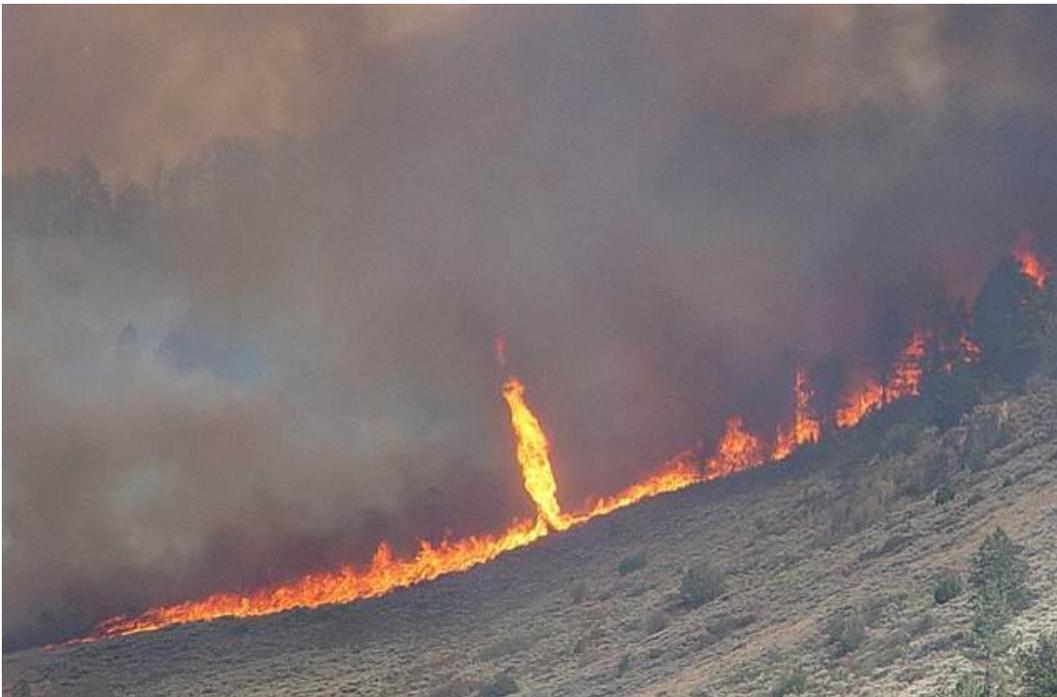
31. Real-world fire whirls (Figure 7) usually move slowly. Fire whirls can set objects in their paths ablaze and can hurl burning debris out into their surroundings. The winds generated by a fire whirl can also be dangerous. Large fire whirls can create wind speeds of more than 100 mph - strong enough to knock down trees.

Figure 7. Representative photo of a fire whirl approximately 40- 50 foot tall.

1. OAS Aviation Safety Division outsource the development of training on fire whirls and the potential impact to flight operations to include best practices and industry accepted procedures when encountering a fire whirl and the environmental conditions that influence this hazard in order to proactively plan/mitigate it?
2. BLM emphasize the importance of relevant PASPs and require that they be reviewed and approved by management at least annually. Review Appendix B of OPM 06 which can be located at <http://oas.doi.gov/library/opm/CY2014/OPM-06.pdf>
3. OAS Aviation Safety Division develop a Lessons Learned publication to alert all aviation personnel on the dangers of fire whirls.
4. OAS review and clarify OPM 06, requiring that Project Aviation Safety Plans be reviewed annually along with station / unit Aviation Plans.

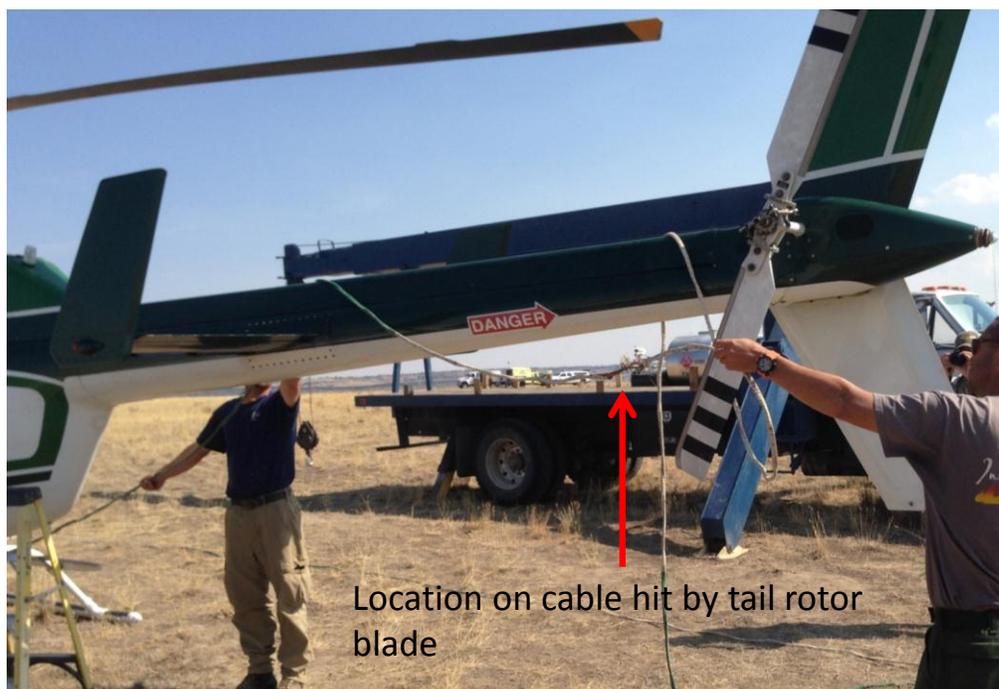
32. The pilot stated that he felt the aircraft climb at approximately 3,000 feet per minute (fpm) just after seeing the fire whirl. As he reduced power to arrest the rate of climb, the Bambi bucket was still influenced by the very strong updraft. During the short period of time between the large power reduction, level off and continued ascent of the Bambi bucket, the 100 foot cable wrapped around the tail boom, missing the main rotor blades and only impacting one tail rotor blade.

34. According to the pilot, the cable came up in front of the right horizontal stabilizer, went over the tail boom and behind the left stabilizer (figure 8). There were no witnesses to the event.

Figure 8. Re-enactment of the cable wrapped around the tailboom.
