**Issue Date:** 26 JUL 10

**Subject:** Incorrect Installation of Chute Locking Nuts

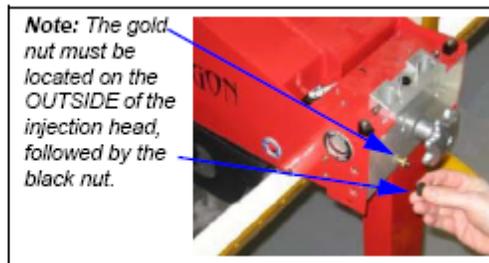
Several incidents have occurred when an operator incorrectly installed the outlet chute to the injection head. The gold nuts were left on the chute screws on the inside of the head and the black nuts on the outside. This action caused the chute to be offset inboard and blocked the primed spheres from exiting the dispenser.

- Attach and secure the outlet chute, using a thumbnut and locking thumbnut on each screw.

To prevent further occurrence, page 22 of the Red Dragon Operations manual has been revised with a note to clearly identify that both sets of nuts need to be on the outside of the injection head.
