Issue Date: 22 APR 10

Subject: Gate Jamming in Red Dragon PSD

Reference: Interagency SAFECOM 10-0153

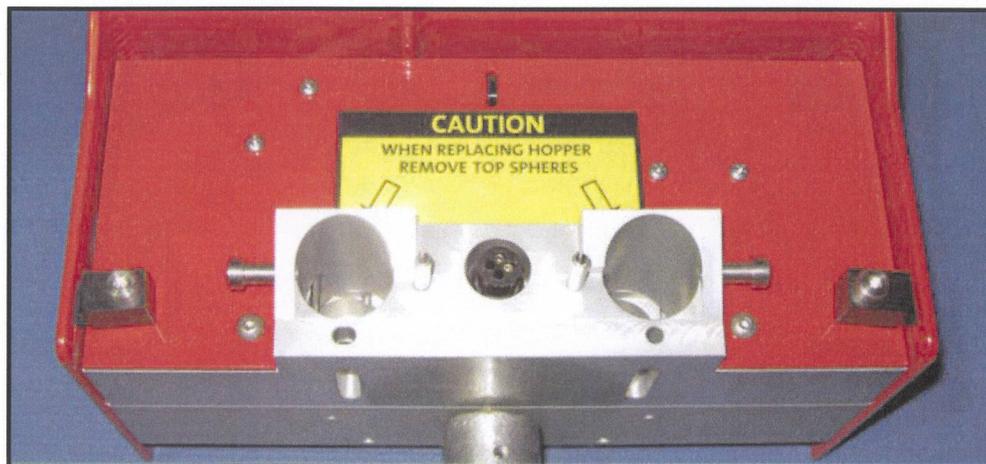
CAUTION

**WHEN REPLACING HOPPER
REMOVE TOP SPHERES**

To prevent further occurrence, a caution label will be affixed to the top of the gate assembly such that the label is visible when the hopper is removed. See photograph.

For existing units, self-adhesive labels and a copy of this bulletin will be sent to the owners and they should be installed in accordance with the photograph.
