Caliente Elevated SAFECOM

1. **SUMMARY.** On August 26, 2011 a lead helitack crewmember was in the process of loading two firefighters and their equipment into a vendor-operated AS 350 B2 helicopter when he attempted to “toss” a chainsaw file out from under the operating rotor system. The file struck one main rotor blade damaging it to the point that the rotor blade had to be replaced. There were no injuries and the mishap was immediately reported using proper protocols.

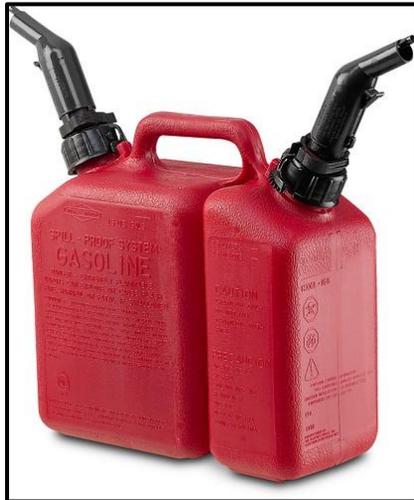
5. As he was securing a “dolmar” (plastic container with two compartments for fuel and oil) (figure 1) in the external basket the lead helitack crewmember observed a chain saw file (figure 2) loosely wedged between the two compartments of the dolmar. The lead helitack crewmember took the file and, without thinking, tossed it behind him (to clear the rotor system).

Figure 1. Example of a Dolmar fuel/oil container.

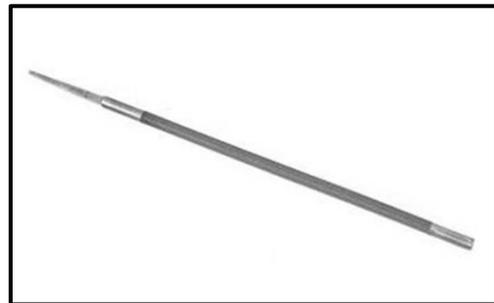
Figure 2. Example of a chainsaw file.

6. The file struck and damaged one main rotor blade but fortunately did not strike any of the personnel around the helicopter. The lead helitack crewmember was unaware that the file had struck the rotor blade until an observer outside of the rotor system told him of the incident.
